Northgate Inspection Ltd.

Field Inspection Report

# Riverside Apartments · Annual Structural Inspection

| Ref. No. | INSP-2026-014 |

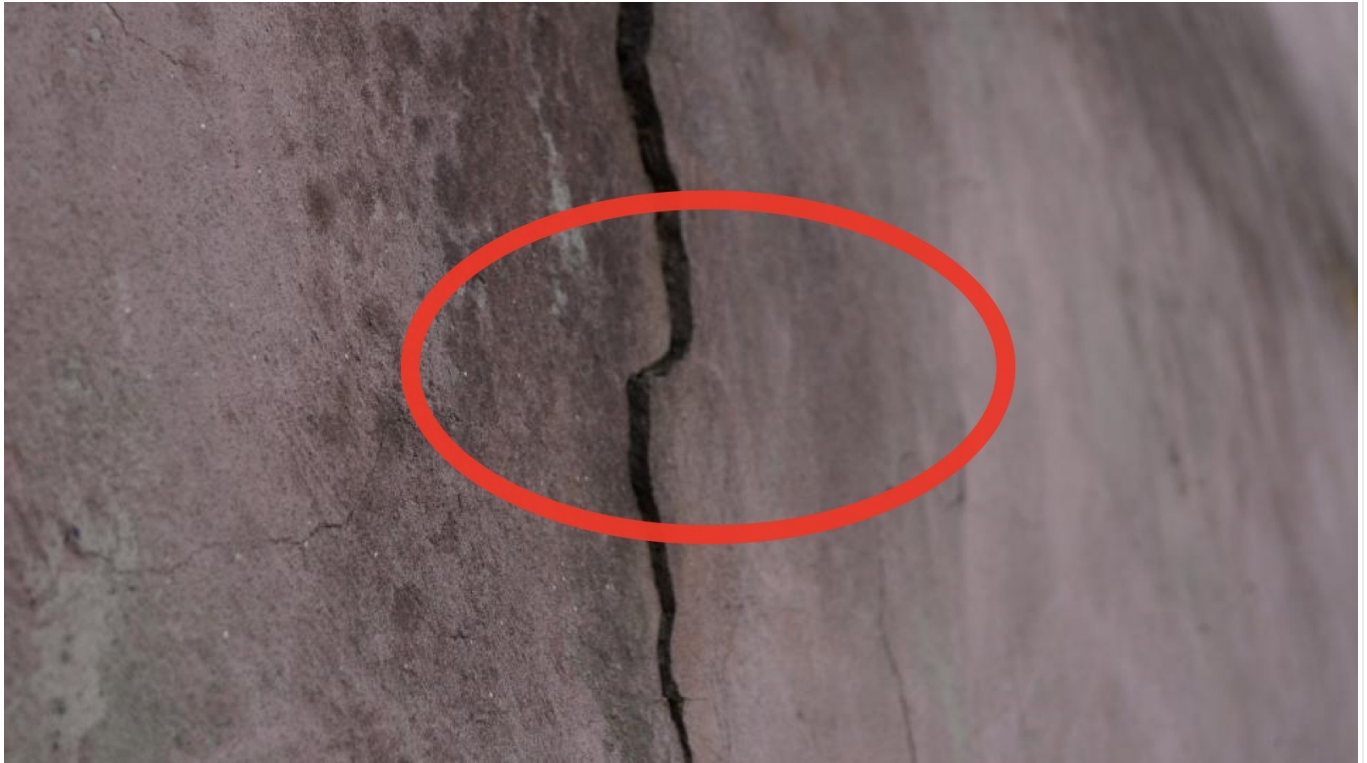
Fig. 1

## 1 Fine crack near window frame

An ~45 cm diagonal crack runs from below the SE window frame, consistent with minor structural settlement. Monitor for widening; seal before the rainy season to prevent water ingress, and arrange a structural engineer assessment.

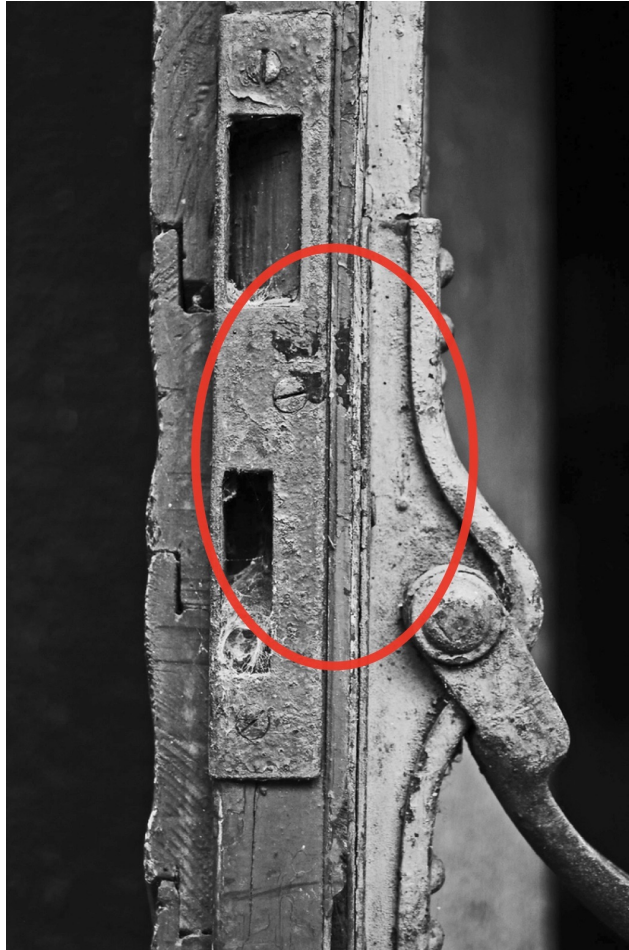
Fig. 1

### 3 Damaged entrance door lock

The entrance latch mechanism is corroded and does not fully latch, affecting security. Replacement with a stainless mortice lock is scheduled; interim patrol notified.

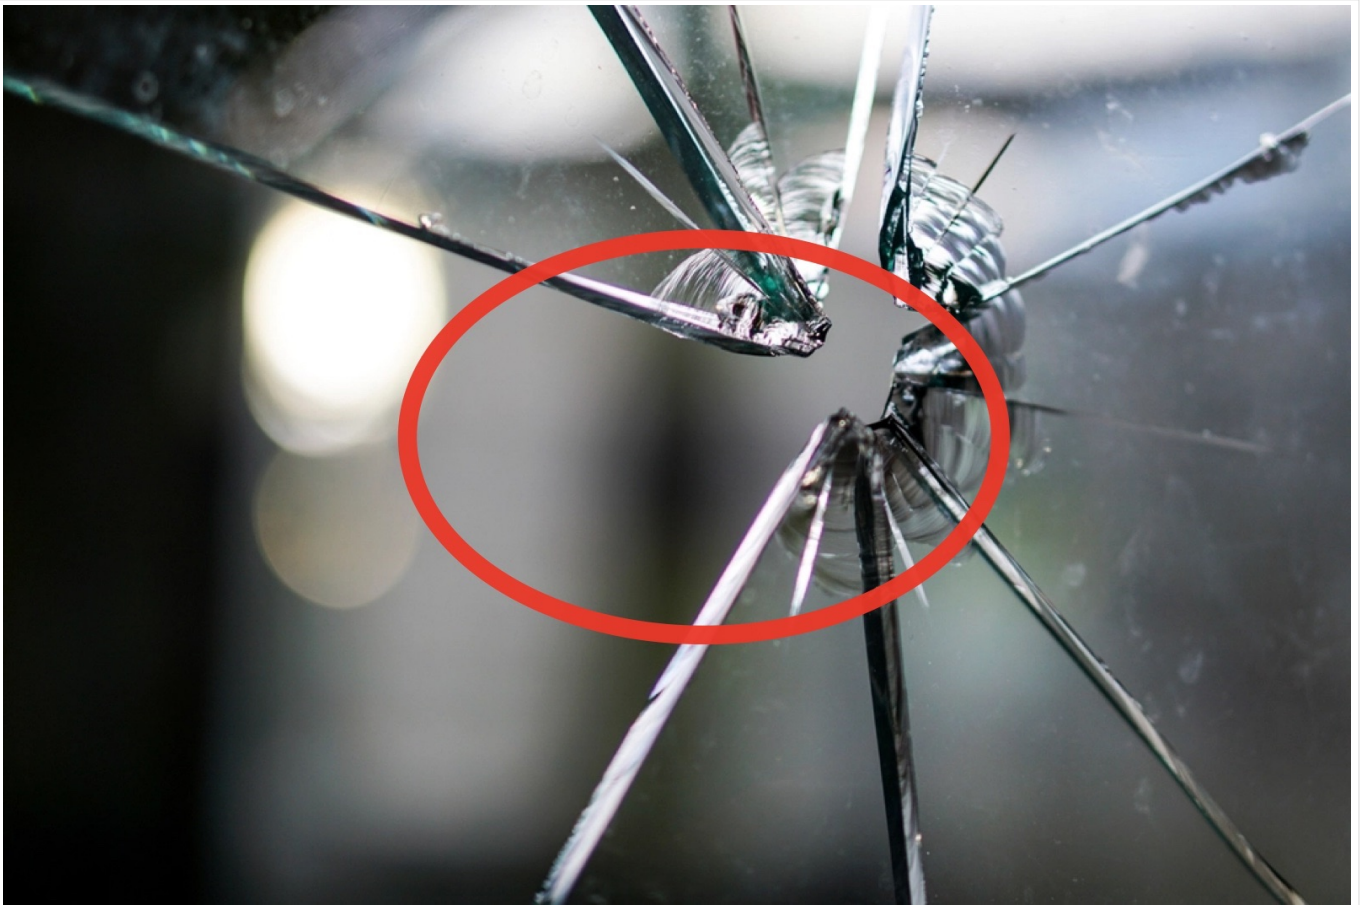
Fig. 1

## 4 Cracked window pane

A ~15 cm radial impact crack on the bedroom window pane. No glass lost yet; taped as a temporary measure. A glazier will replace the pane this week.

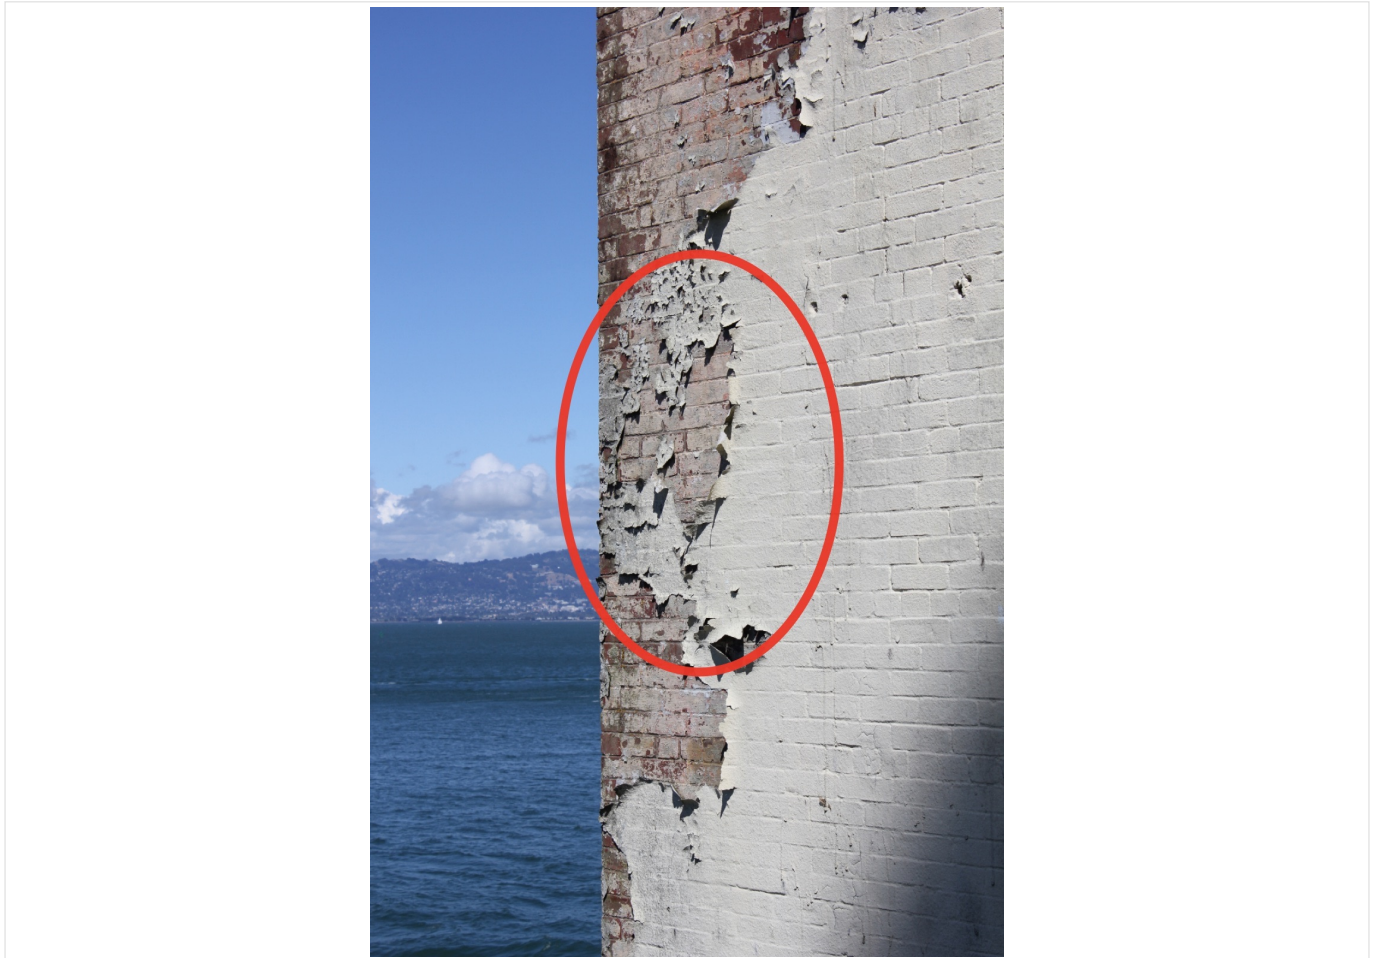
Fig. 1

## 5 Paint delamination, east facade

The previous paint coat was flaking extensively on the east facade, exposing the render. The area was scraped, primed, and repainted; accepted on inspection.
