Field Inspection Report

# Riverside Apartments · Annual Structural Inspection

| Ref. No. | INSP-2026-014 |
| Inspection date | Jul 27, 2026 |

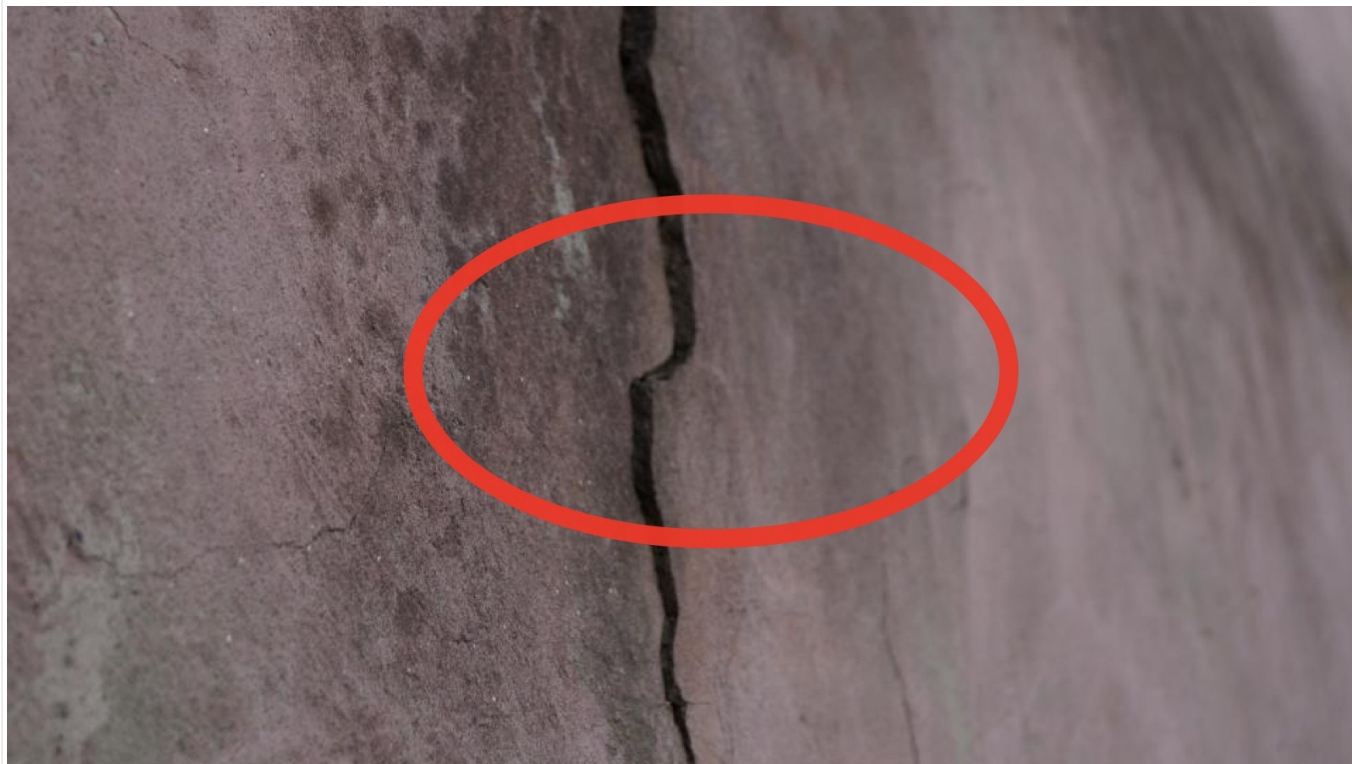
Fig. 1

| # | Issue | Status | Priority | Location |
|---|---|---|---|---|
| 1 | Fine crack near window frame | <div><div></div>To do</div> | <div><div></div>High</div> | Living room · SE corner |

## ● Fine crack near window frame

● To do ● High ● Living room · SE corner · Chen Siyuan 2026/7/27, 18:37

An ~45 cm diagonal crack runs from below the SE window frame, consistent with minor structural settlement. Monitor for widening; seal before the rainy season to prevent water ingress, and arrange a structural engineer assessment.

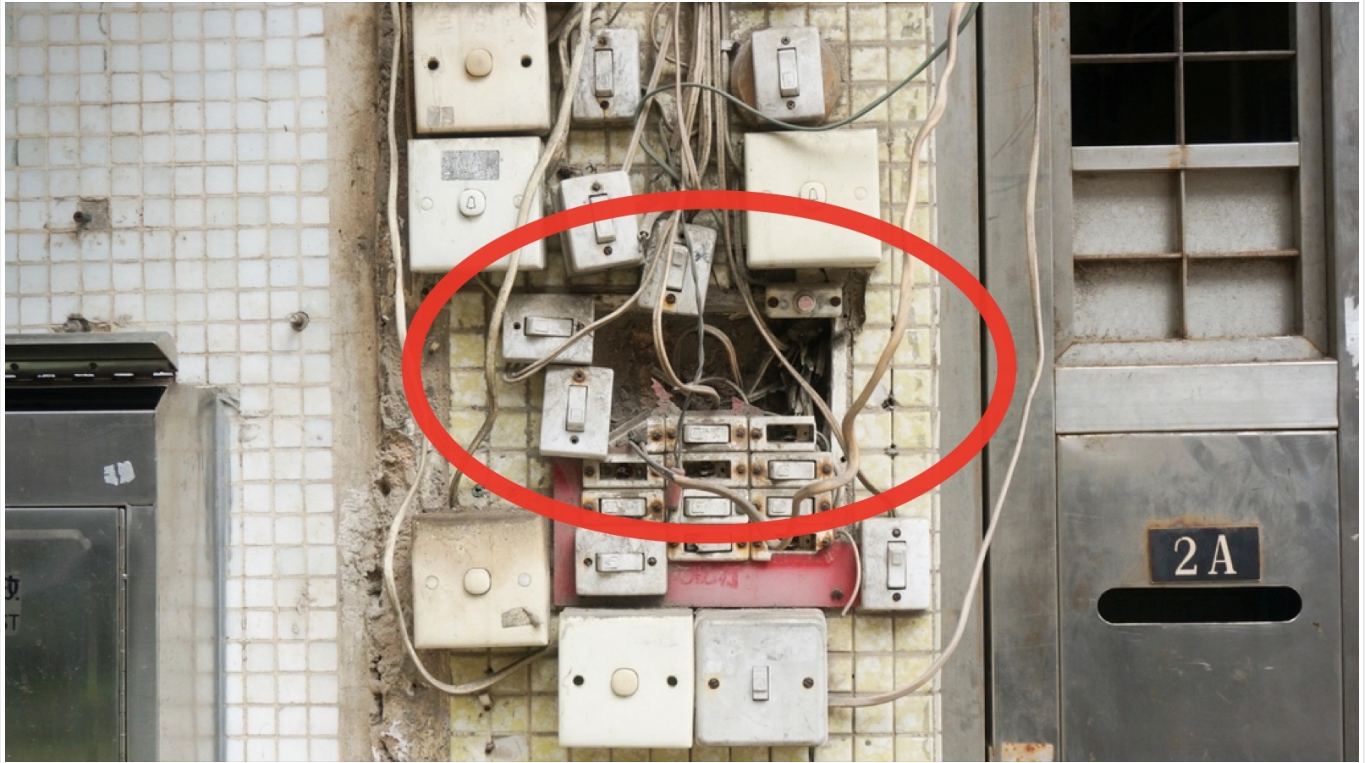
Fig. 1

| # | Issue | Status | Priority | Location |
|---|---|---|---|---|
| 2 | Exposed wiring at junction box | <div><div></div>In progress</div> | <div><div></div>Urgent</div> | Corridor · electrical ca... |

## ● Exposed wiring at junction box

● In progress ● Urgent ● Corridor · electrical cabinet · Li Wentao 2026/7/27, 18:37

Several conductors are exposed at the corridor junction box and the cover plate is missing, an electric-shock hazard. Circuit isolated; a licensed electrician will reinstate the cover and terminate the conductors.

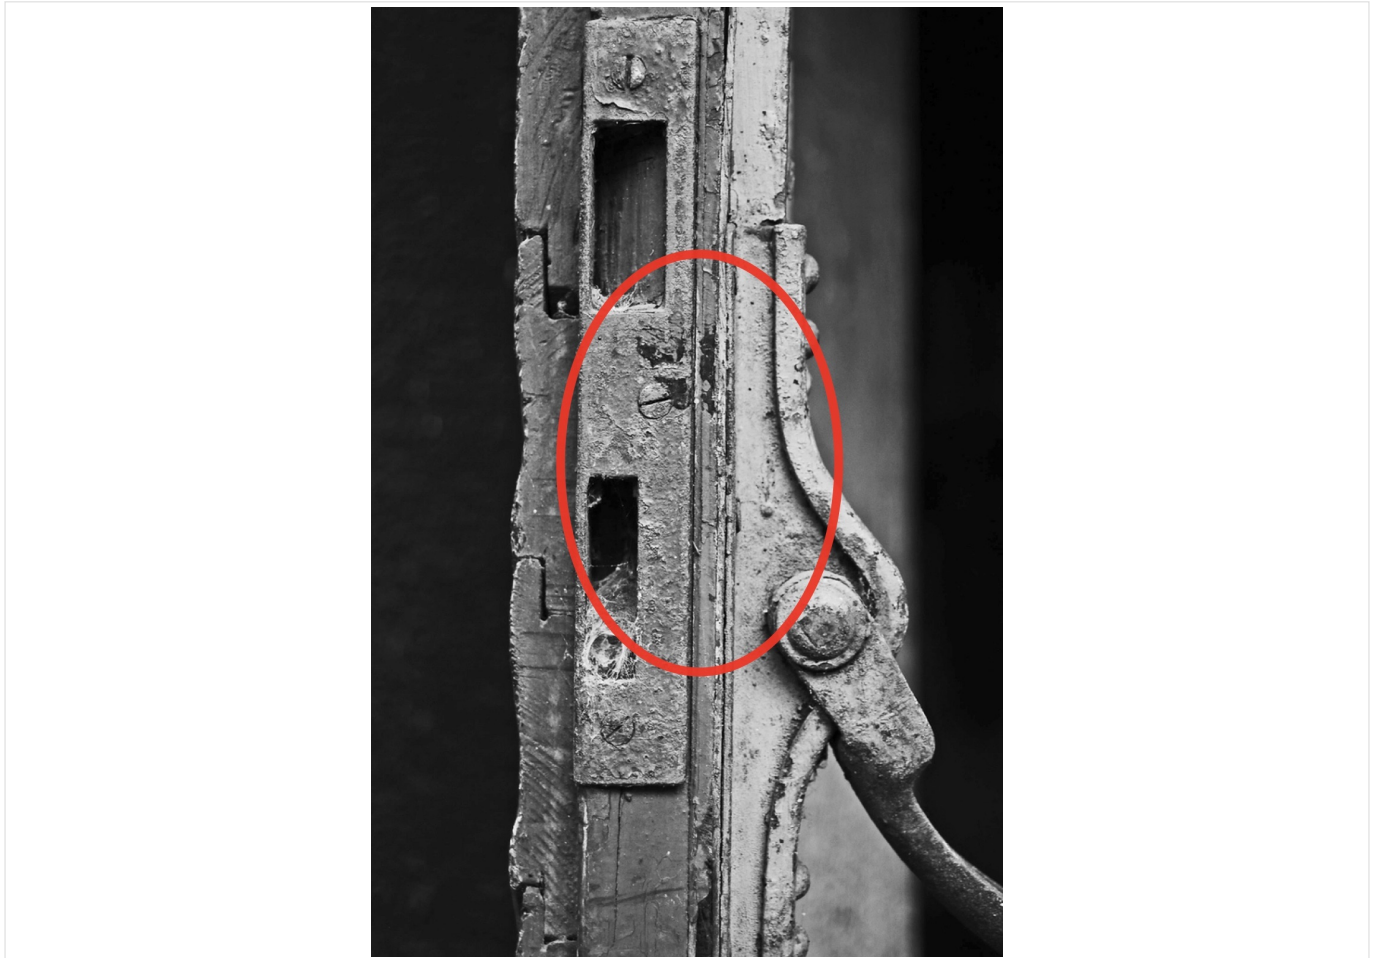
Fig. 1

| # | Issue | Status | Priority | Location |
|---|---|---|---|---|
| 3 | Damaged entrance door lock | <div><div></div>In progress</div> | <div><div></div>High</div> | Main entrance · Unit 4 |

## ● **Damaged entrance door lock**

● In progress ● High ● Main entrance · Unit 4 · Li Wentao 2026/7/27, 18:37

The entrance latch mechanism is corroded and does not fully latch, affecting security. Replacement with a stainless mortice lock is scheduled; interim patrol notified.

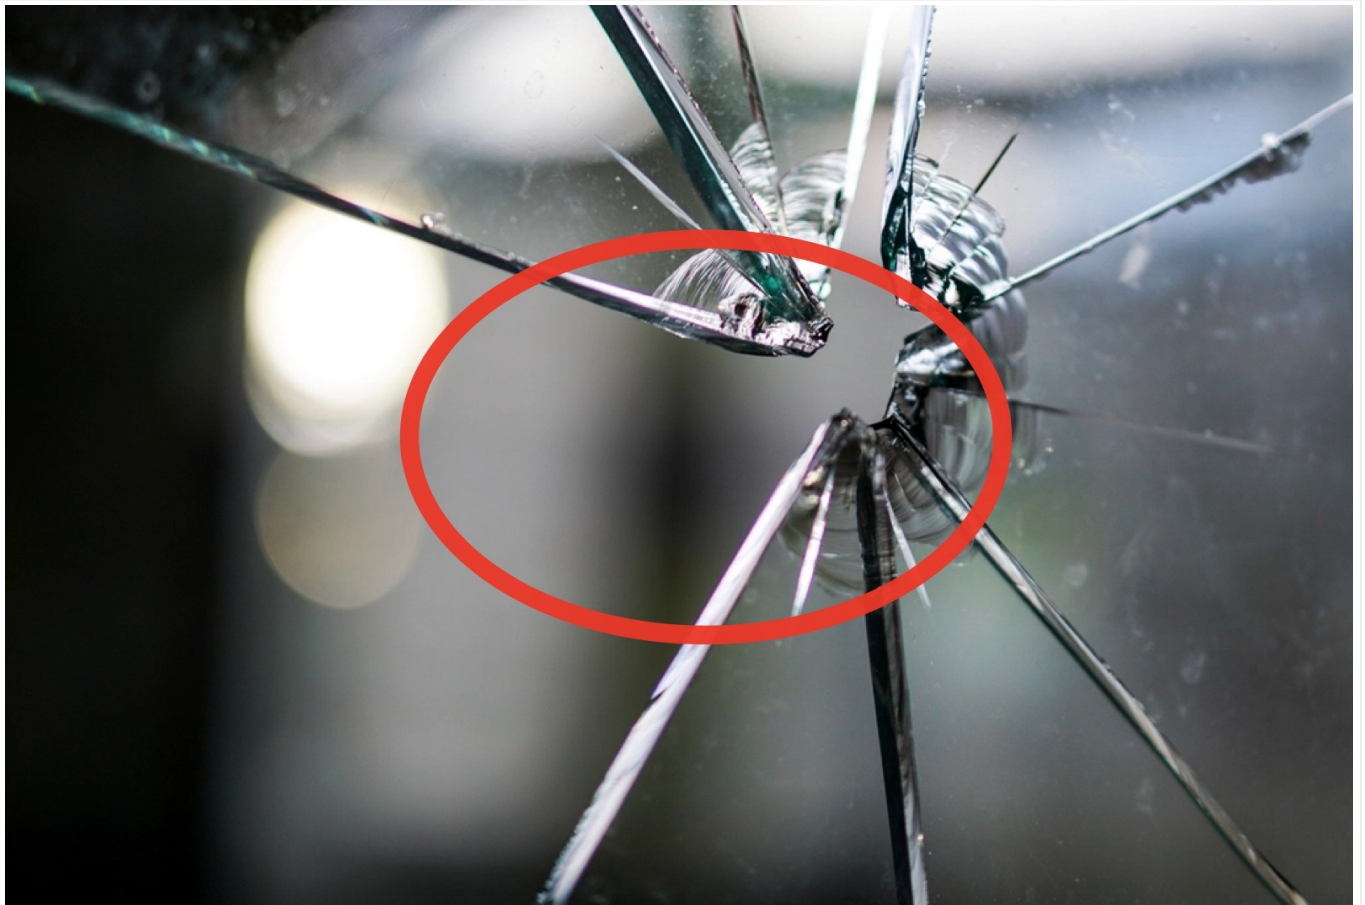
Fig. 1

| # | Issue | Status | Priority | Location |
|---|---|---|---|---|
| 4 | Cracked window pane | <div><div></div>To do</div> | <div><div></div>Normal</div> | Bedroom · east-facing |

## ● Cracked window pane

● To do ● Normal ● Bedroom · east-facing · Li Wentao 2026/7/27, 18:37

A ~15 cm radial impact crack on the bedroom window pane. No glass lost yet; taped as a temporary measure. A glazier will replace the pane this week.
