Riverside Apartments · Annual Structural Inspection

Riverside Properties Ltd.

INSP-2026-014

Jul 27, 2026

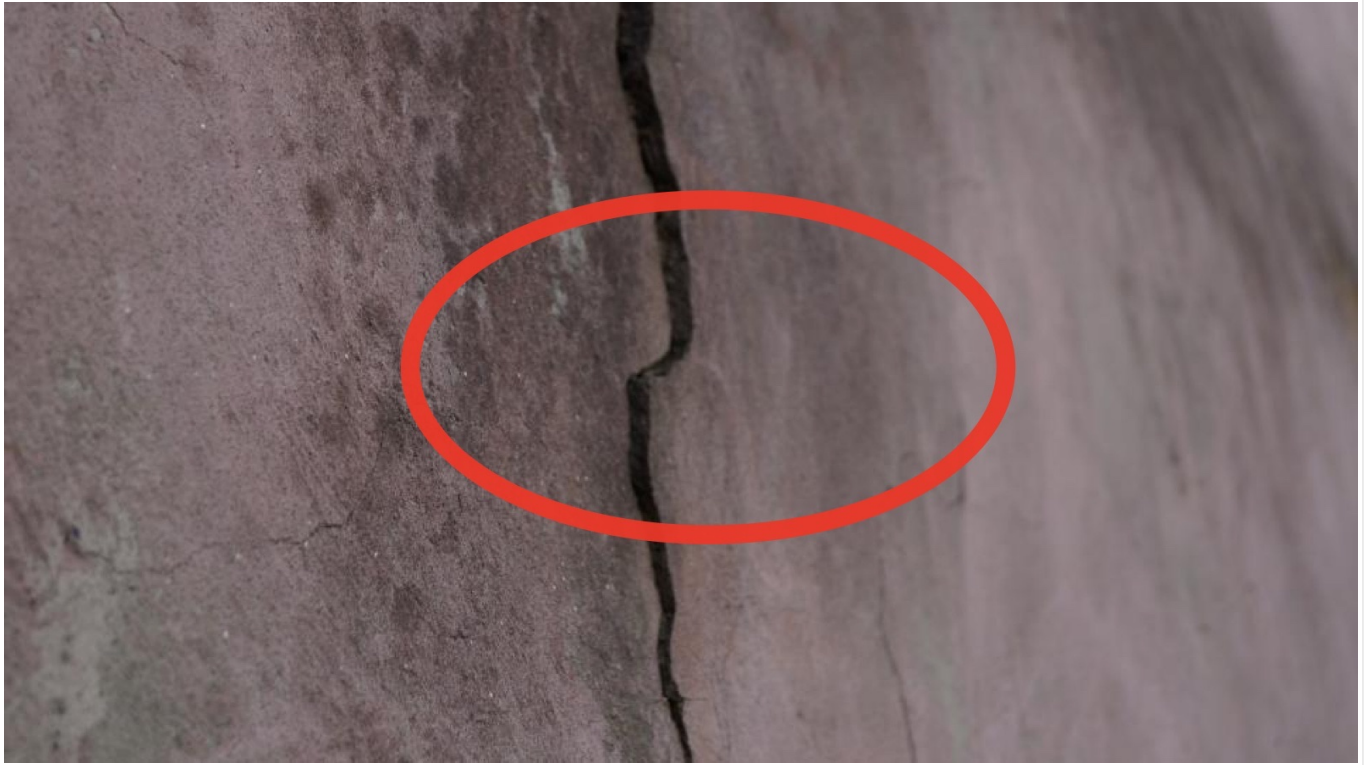
Fig. 1

## 01 Fine crack near window frame

An ~45 cm diagonal crack runs from below the SE window frame, consistent with minor structural settlement. Monitor for widening; seal before the rainy season to prevent water ingress, and arrange a structural engineer assessment.

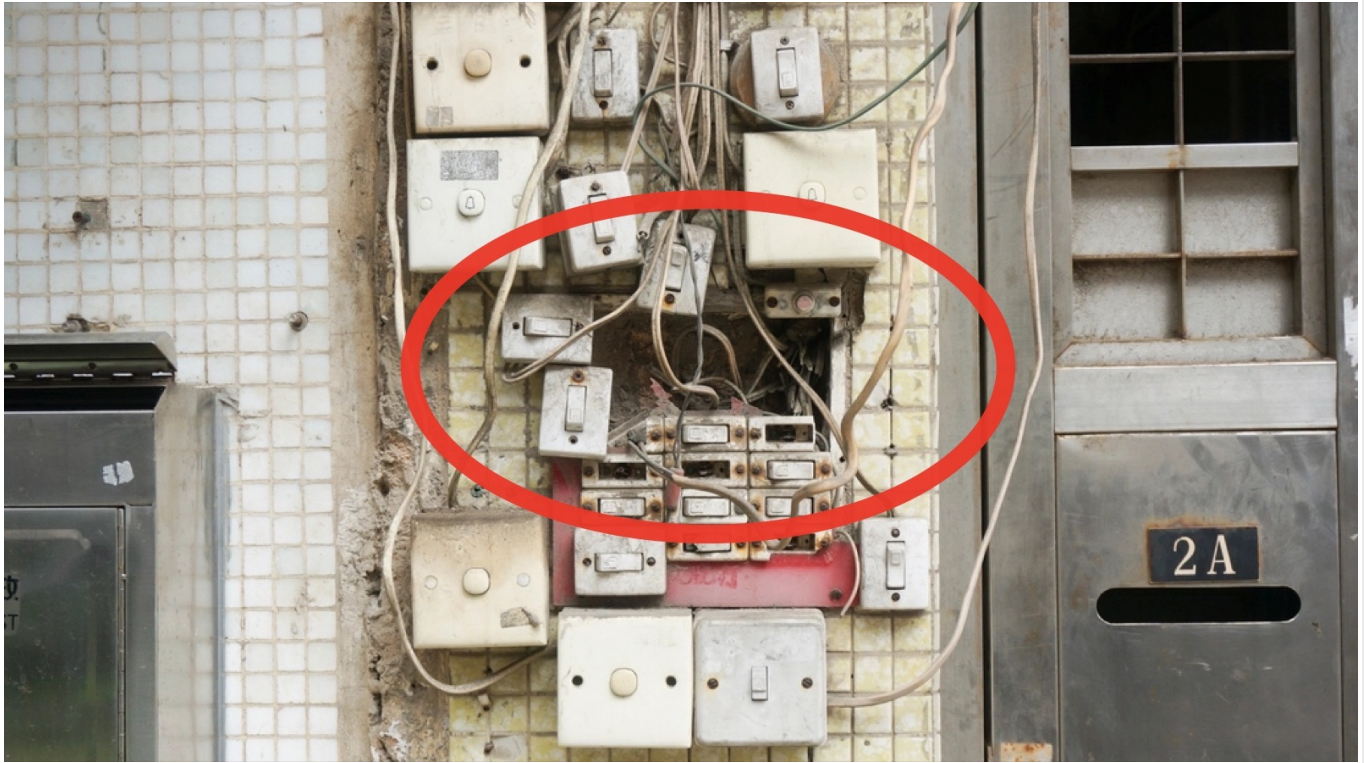
Fig. 1

## 02 Exposed wiring at junction box

Several conductors are exposed at the corridor junction box and the cover plate is missing, an electric-shock hazard. Circuit isolated; a licensed electrician will reinstate the cover and terminate the conductors.

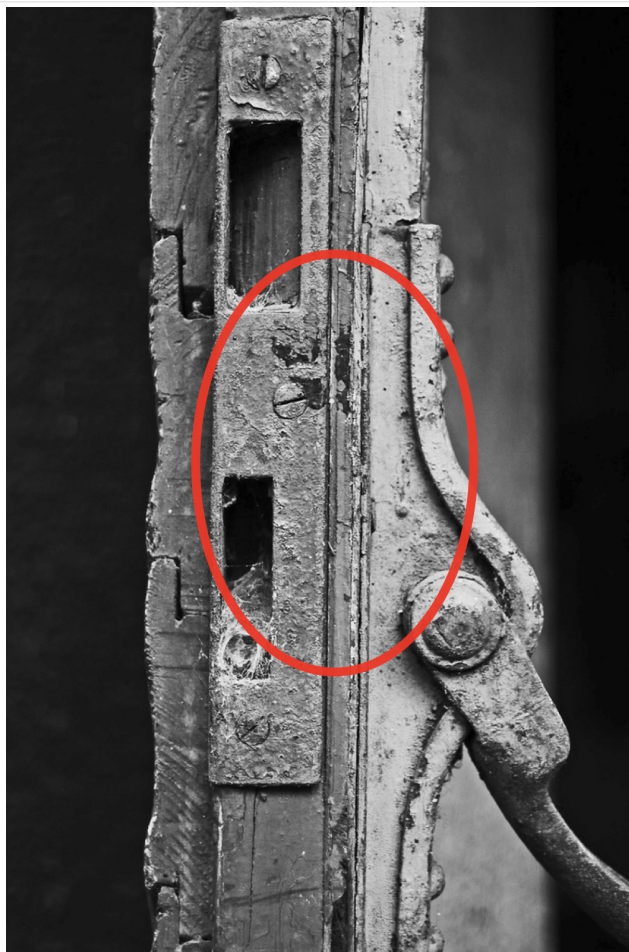
Fig. 1

### 03 Damaged entrance door lock

The entrance latch mechanism is corroded and does not fully latch, affecting security. Replacement with a stainless mortice lock is scheduled; interim patrol notified.

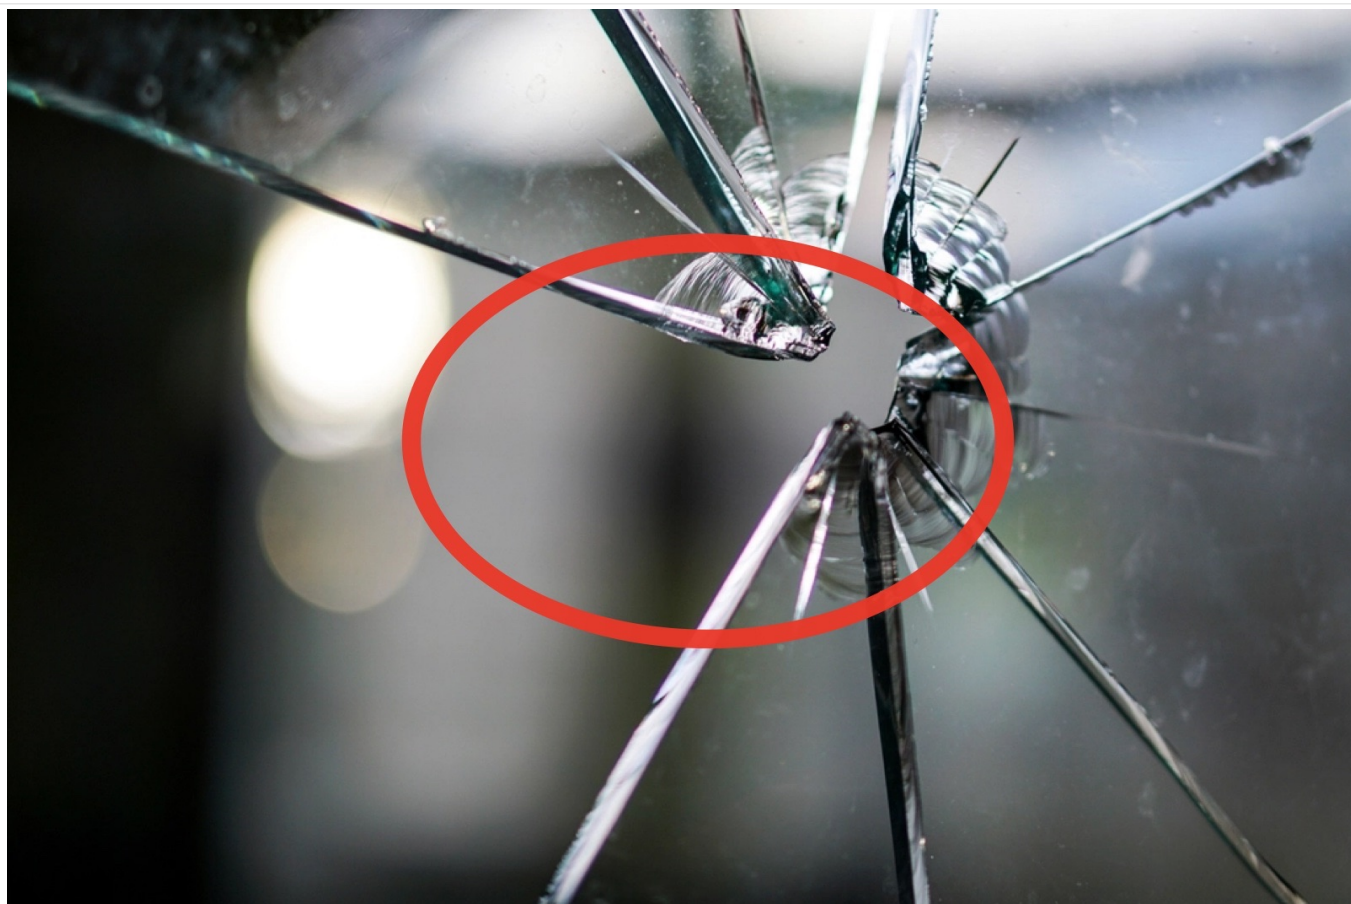
Fig. 1

## 04 Cracked window pane

A ~15 cm radial impact crack on the bedroom window pane. No glass lost yet; taped as a temporary measure. A glazier will replace the pane this week.

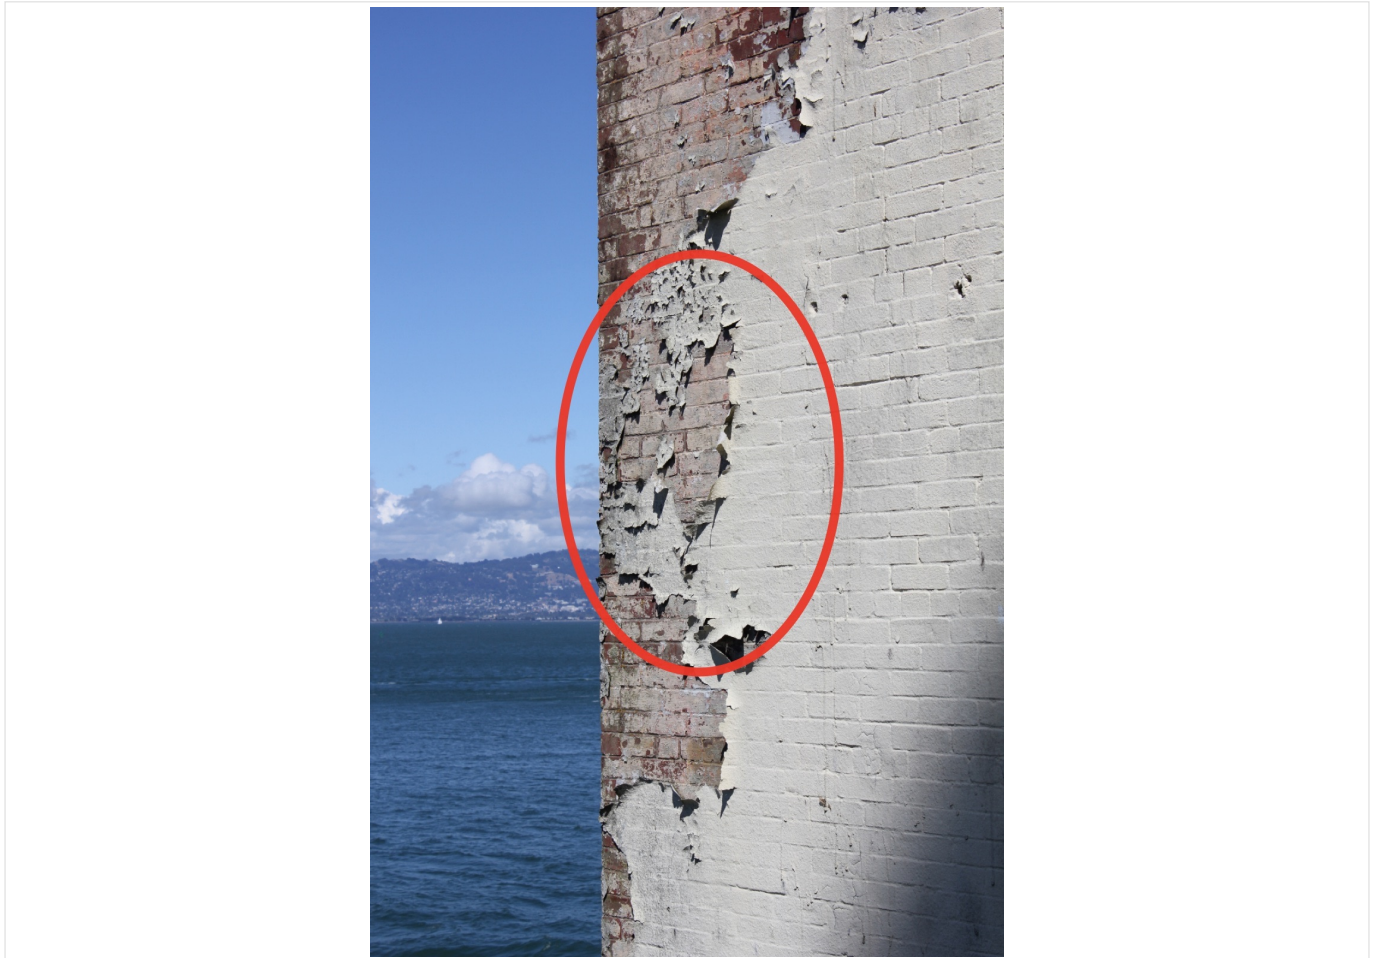
Fig. 1

## 05 Paint delamination, east facade

The previous paint coat was flaking extensively on the east facade, exposing the render. The area was scraped, primed, and repainted; accepted on inspection.
